# BROKEN BROOKS

Restoring Fish Passage and Habitat in the  
Petitcodiac Watershed

Report

2024 - 2025

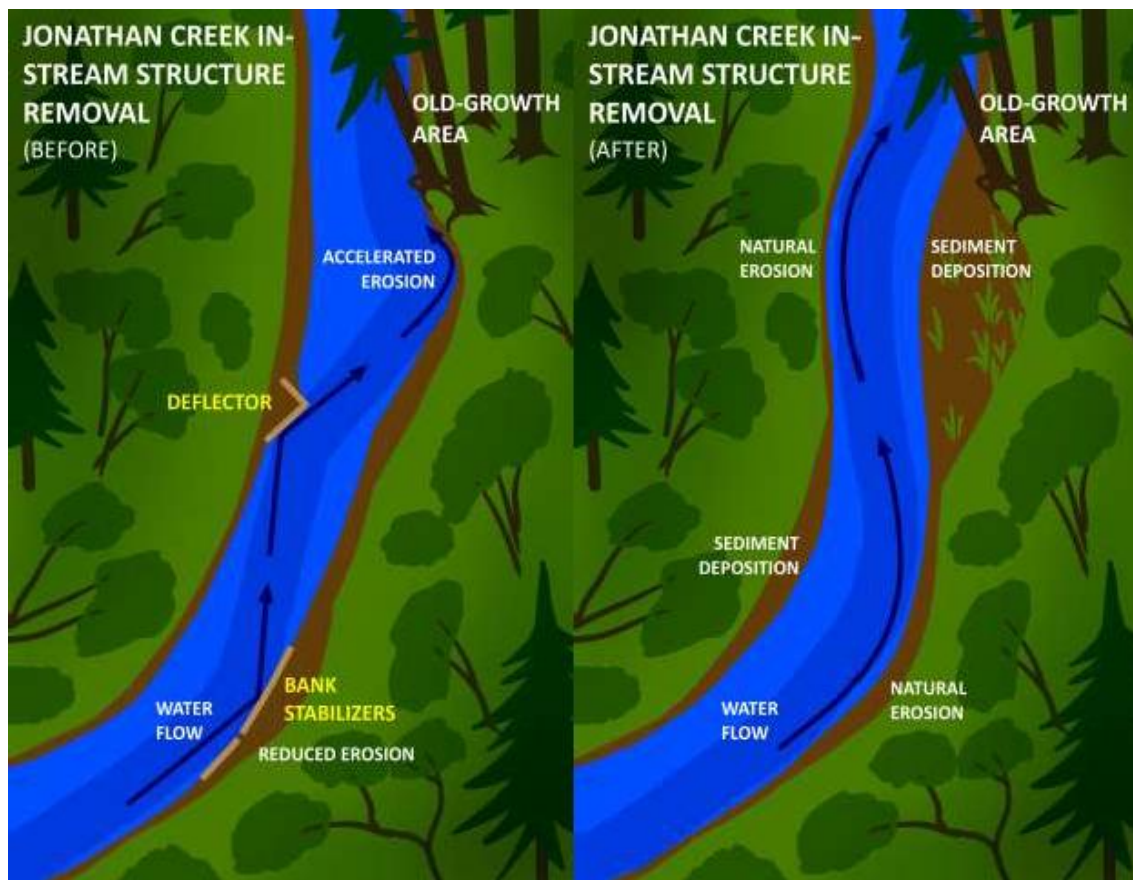
Figure 1. Bank stabilizer (JC-L04) and wing deflector (JC-L05) causing accelerated erosion into an old-growth area downstream before removal (left) and predicted flow after structure removal (right).

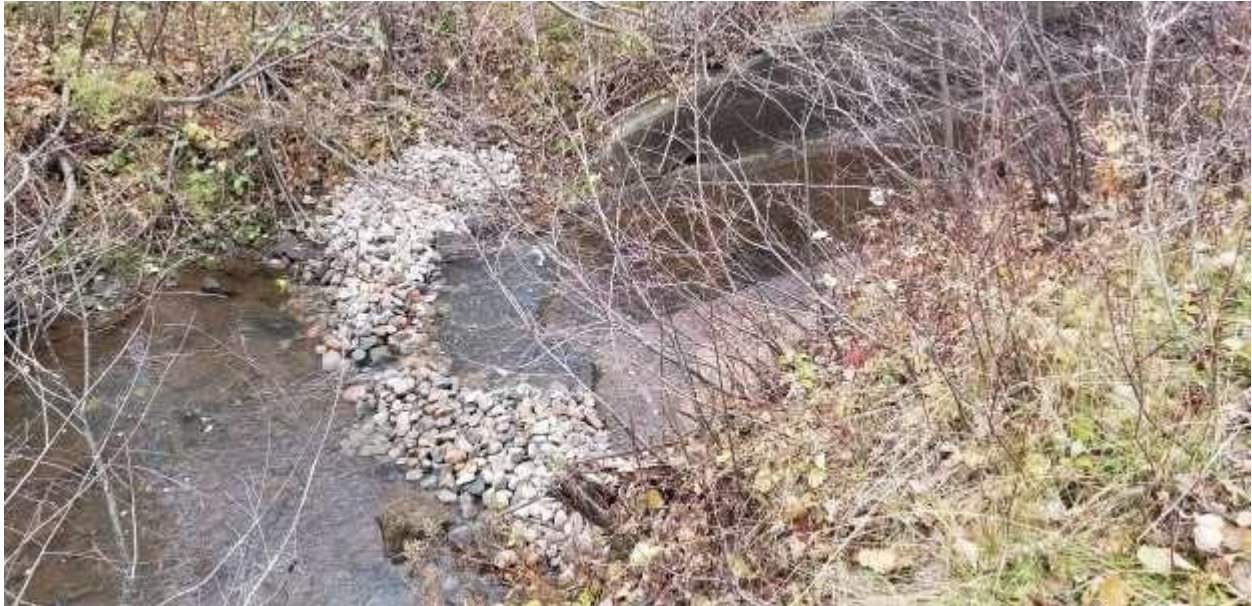
*Figure 2: Rock weir constructed in 2020, located in the Halls Creek sub-watershed.*

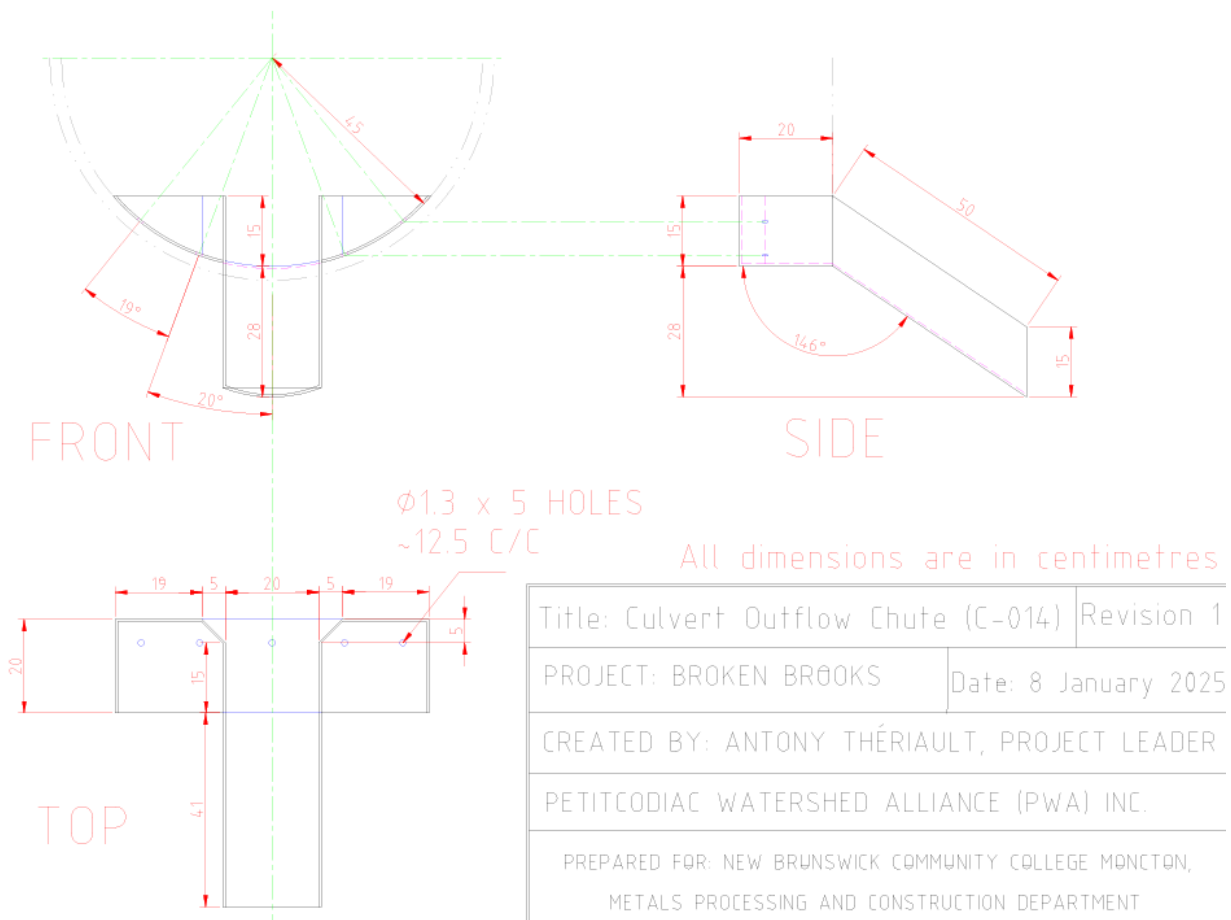
Figure 3: Front, top, and side views with dimensions of the outflow chute for culvert C-014.

In June 2025, we installed an outflow chute at the C-014 culvert, located on a tributary in the Little River sub-watershed (45.8251, -65.0523), creating 2.9 km of upstream habitat. During the very dry conditions this summer, it became clear that a rock weir would be needed to raise the water level in the outflow pool. The planning and installation of the rock weir are expected to take place in 2026.

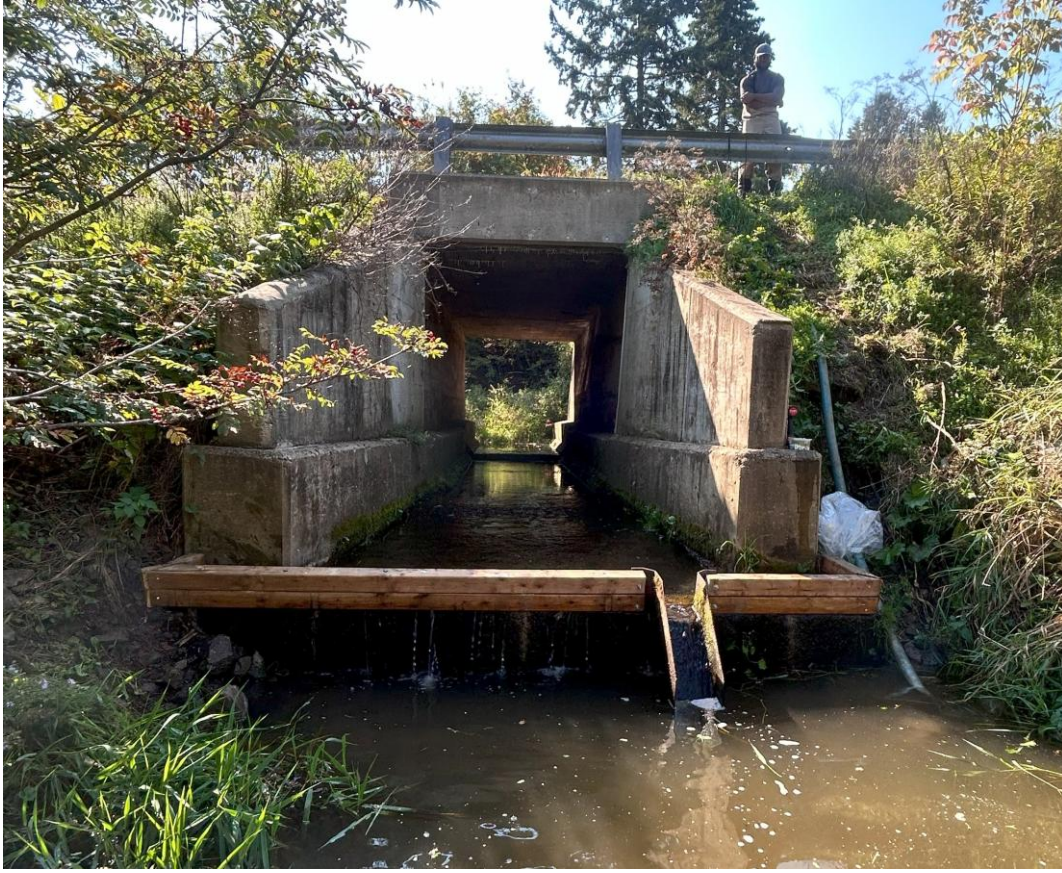
*Figure 7: Outflow chute at culvert C-011 repaired in September 2024.*

The outflow chute at culvert C-011, located in the Pollet River sub-watershed, was repaired in September 2024, restoring access to 1.72 km of upstream habitat.
