# Petitcodiac And Memramcook Water Quality Report

Petitcodiac Watershed Monitoring Group  
Po Box 23046  
236 St. George, Suite 109  
Moncton, New Brunswick E1A 6S8

Arseneau, E. and B.Pavey, W.Kingston, L.Doiron. 2006. Petitcodiac and Memramcook Water Quality Report. Report produced by the Petitcodiac Watershed Monitoring Group. Moncton, New Brunswick. 44pp.

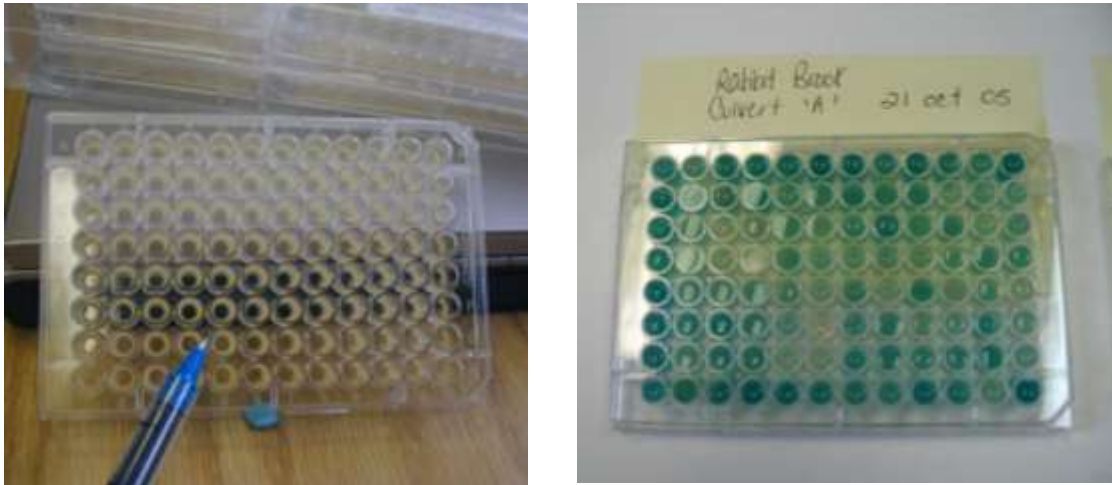
The ColiPlate© method was used to test for *E.coli* and Total coliforms (Figure 1). The tests were done in conjunction with l'Université de Moncton at their laboratory facilities. Once the plates were prepared, they were put into an incubator at 35°C for 24 hours. The incubated microplates were placed on a white surface and the number of wells that turned blue indicated a positive reaction for Total coliforms (EBPI 2003). To determine *E.coli* levels, the incubated plates were then placed on a black surface and observed under a long wavelength UV light (366 nm). The wells that both turn blue and fluoresce under the UV light are *E.coli* positive. Bacteria levels are determined by Most Probable Number of bacterial colonies in 100 ml of water. Note that all equipment was sterilized prior to use.

Figure 1. Coliplate©

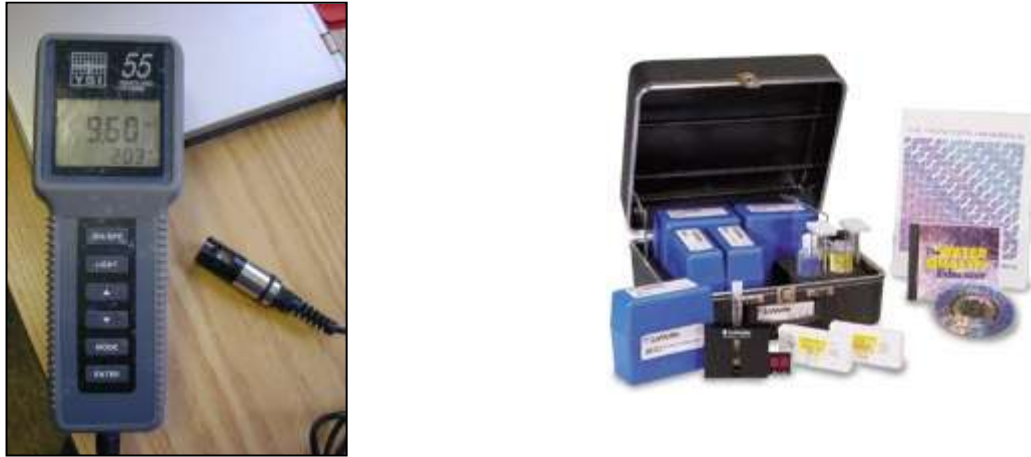
DO and water temperature were monitored using a YSI 55 meter. The pH was calculated using a Lamotte Kit (Figure 2).

Figure 2. YSI 55 meter and Lamotte pH kit
