In the Fall of 2014, a vortex rock weir was installed on Culvert C051, located where Route 895 intersects Mitton Brook. This crossing had a downstream slope of 3.79% and an outflow drop of 19 cm. This outflow drop was potentially blocking aquatic access to approximately 2.5 km of upstream habitat for brook trout and other species. A rock volume of 1 m³ was calculated.

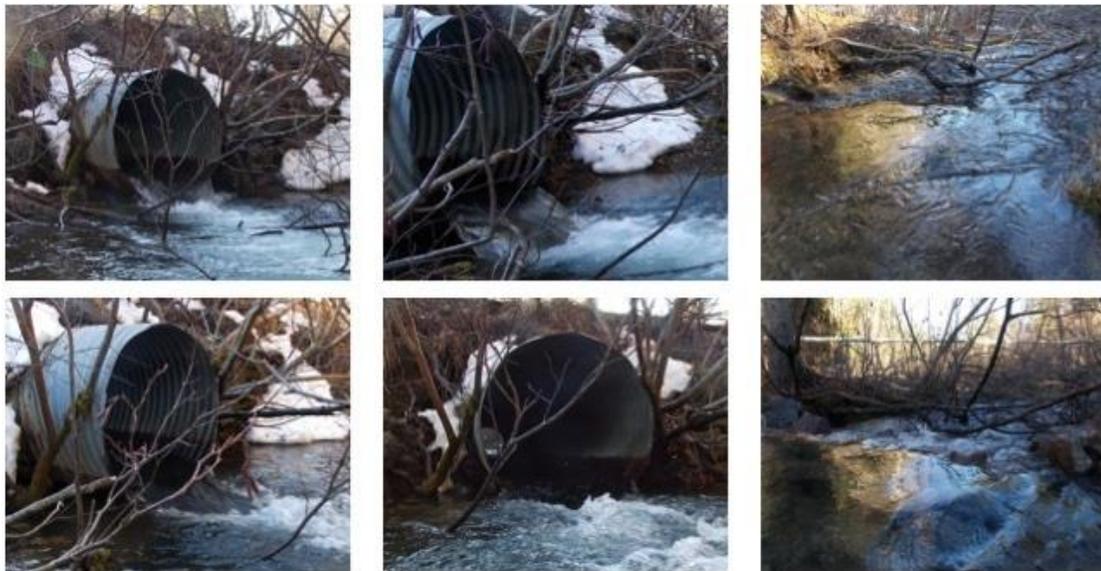
Figure 19 displays an immediate reduction in the outflow drop after the the rock weir was installed on Culvert 51 in the Little River Basin.

Figure 1: Photos of the 19 cm outflow drop before constructing the rock weir (top left and center) with their corresponding after photos following rock weir completion. (bottom left and

center). The pictures on the right show the tailwater control before (top) and after (bottom) the rock weir was constructed.

The culvert on Mitton Brook had an average bankfull height of 0.440 m and a downstream slope of 3.79%. Given this information, an incipient diameter of 16.676 cm was calculated. The safety factor of two was used to calculate a minimum rock size of 34 cm. For the large, flat footer stones that composed the base of the weir, a safety factor of four resulted in a rock size of 67 cm.

Installing this rock weir allowed fish to gain 2.5 km of upstream habitat that, especially for small or juvenile species, may have otherwise been inaccessible. When the results of remedial efforts from all four debris removals and the tailwater control installation are combined (Table 9), a net upstream habitat gain of 25.5 km was restored to aquatic species in the Pollett and Little River basin.

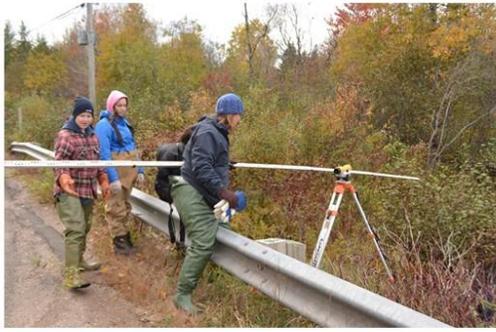
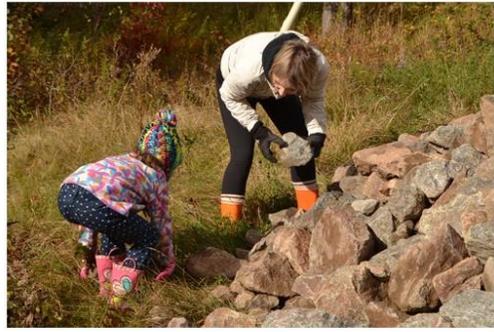
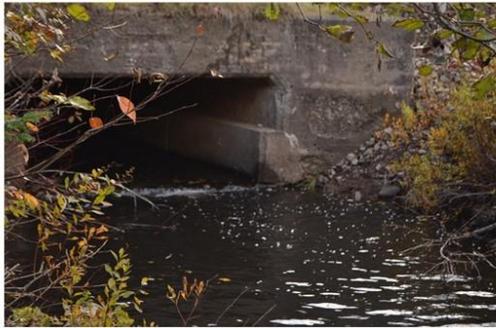
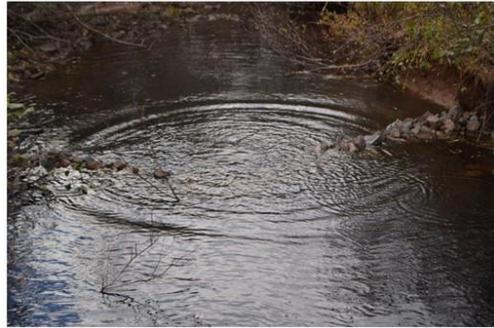
With our high school student and teacher volunteers (Figure 26) fish passage was facilitated to 4.5 km of upstream habitat.

Figure 2: Member of the Blue Action Committee action committee (top left and top right) volunteered their time to construct a rock weir (bottom right) and minimizes the outflow drop at Culver 4 (bottom left).

The third and final rock weir installation took place in the fall with the assistance of the Blue Action Committee (high school students in the Greater Moncton Area interested in environmental learning opportunities) where the Sanatorium Road crosses an unnamed stream. Rock volume and diameter were calculated to order rock from a local rock quarry. Culvert 4 had an outflow drop of 18 cm and a bankfull width of 4.6 m. Given this information a rock volume of 0.47 m^3 was rounded up to 1 m^3 .

An incipient diameter of 8.20 cm was multiplied by two to calculate a minimum rock size of 16.40 cm. For the large, flat footer stones that composed the base of the weir, a safety factor of four resulted in a rock size of 32.80 cm.
