2018

BROKEN BROOKS

ASSESSING AND REMEDIATING CULVERTS IN THE PETITCODIAC WATERSHED

Prepared by Shane Boyd
PETITCODIAC WATERSHED ALLIANCE

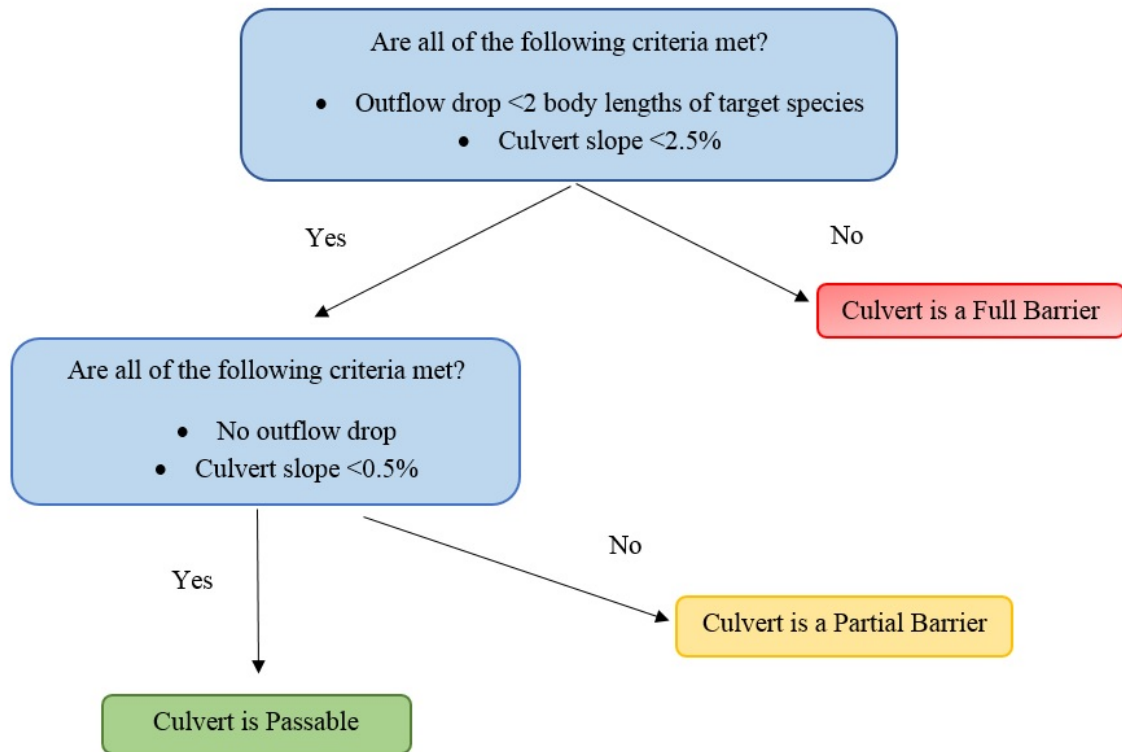
In combination with the table above, the illustration below was consulted to accurately measure each assessed culvert’s ability to pass fish (Figure 1).

Figure 1: Flowchart of culvert conditions determining fish passability

result, only culverts on which remedial work would be successful remain. Finally, images taken during fieldwork are used to verify the culverts' conditions in order to better judge the feasibility of remediation. It is recommended that each site be revisited and remeasured before plans for remedial work begin. One or more remedial techniques are chosen based on the conditions detailed in Table III and Figure 1.

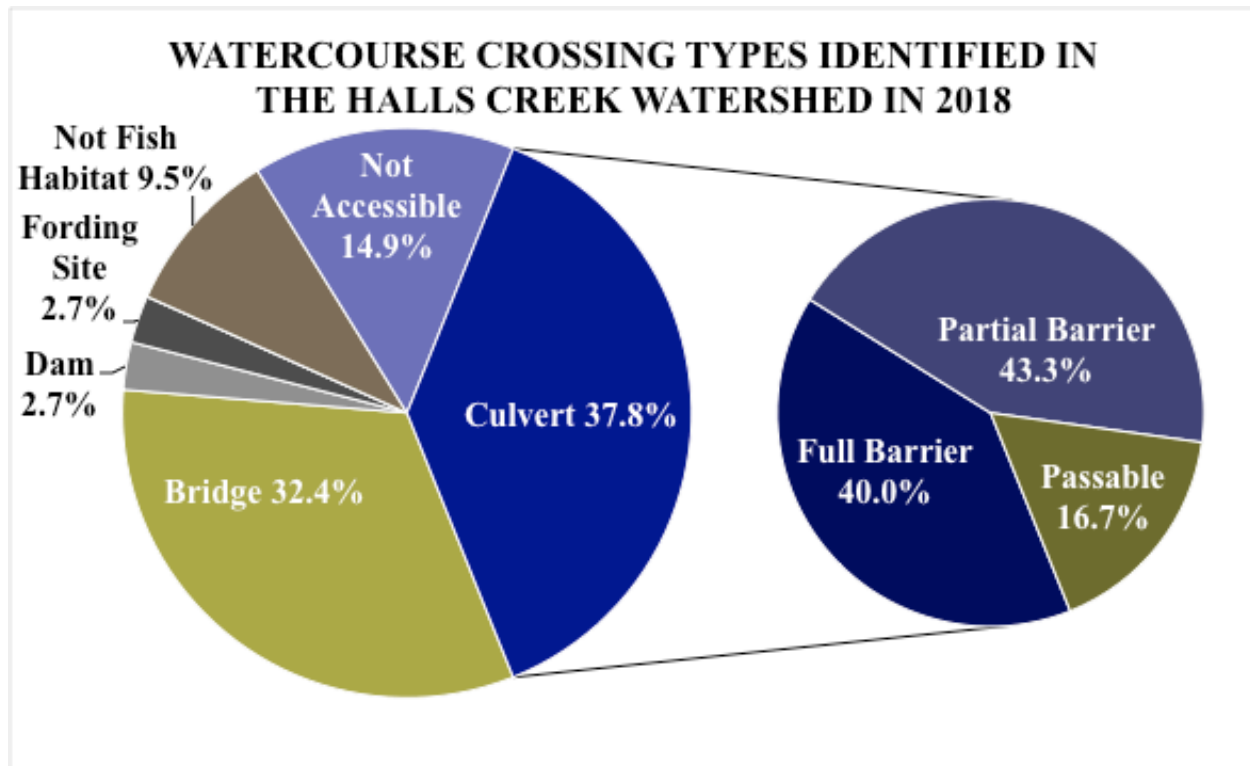
Figure 2: Watercourse crossing types identified in the Halls Creek watershed in 2018

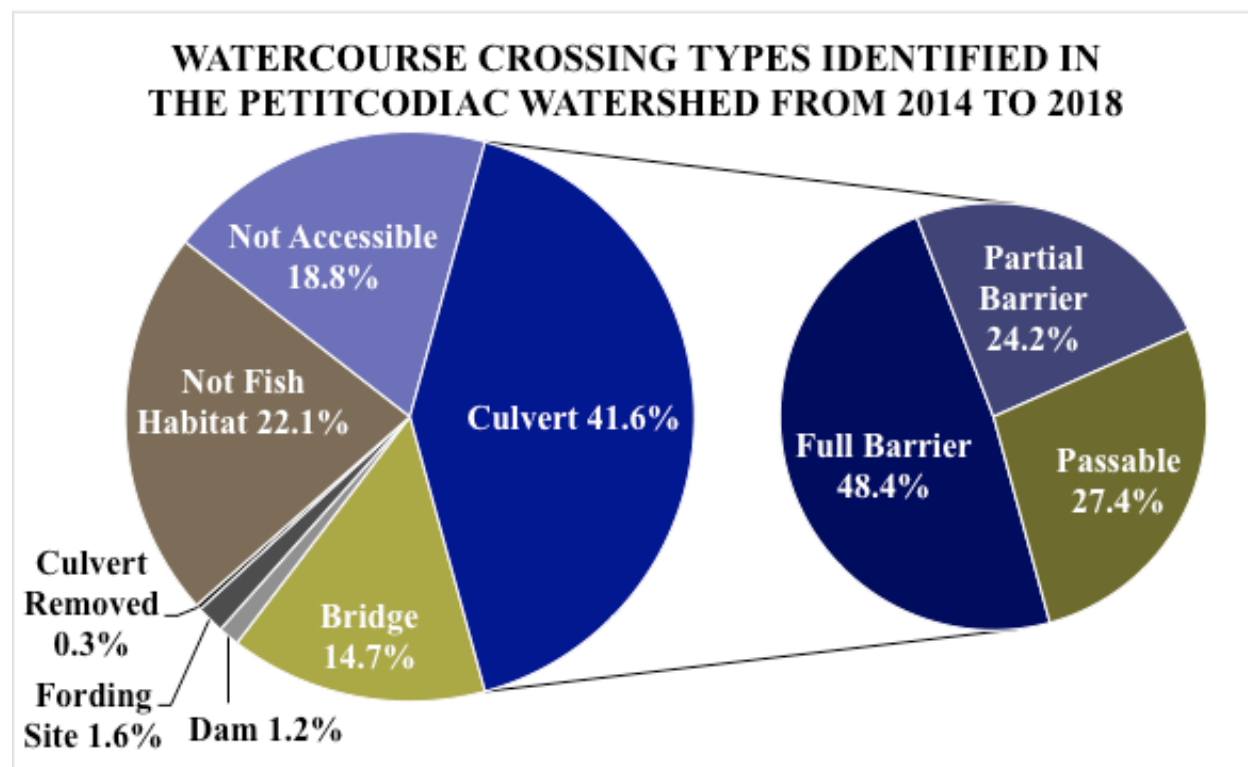
Figure 3: Watercourse crossing types identified in the Petitcodiac watershed from 2014 to 2018

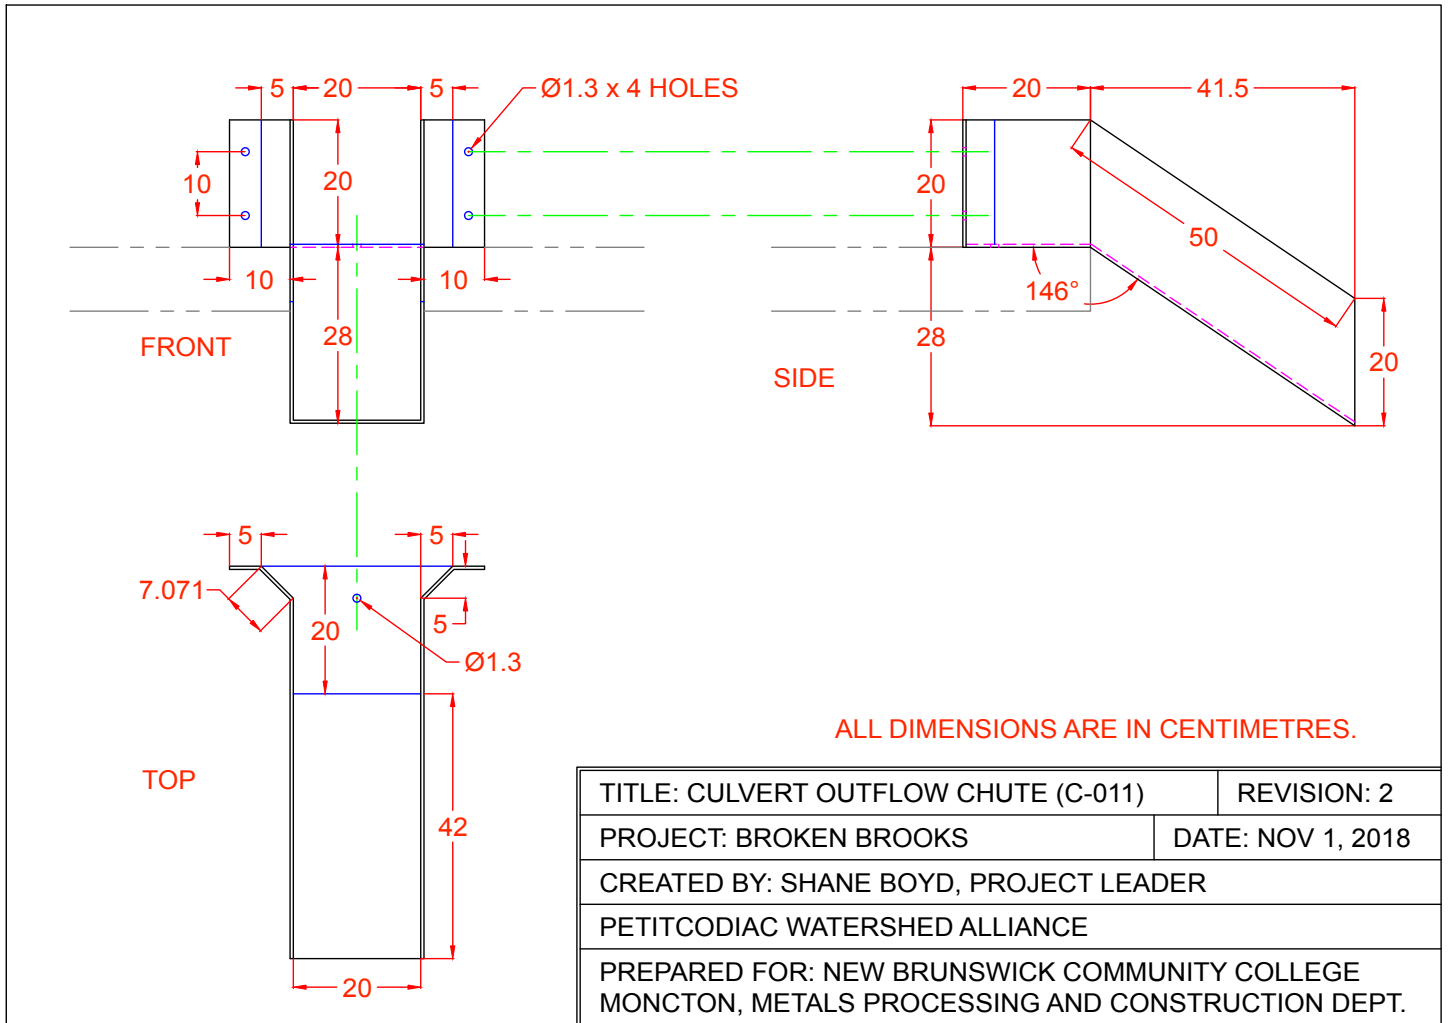
This is the first year that outflow chutes have been designed for installation on culverts in New Brunswick. Thanks to the PWA's partnership with NBCC, two outflow chutes will be constructed by students each winter at low cost.

Figure 4: Front, top, and side views with dimensions of outflow chute for culvert C-011

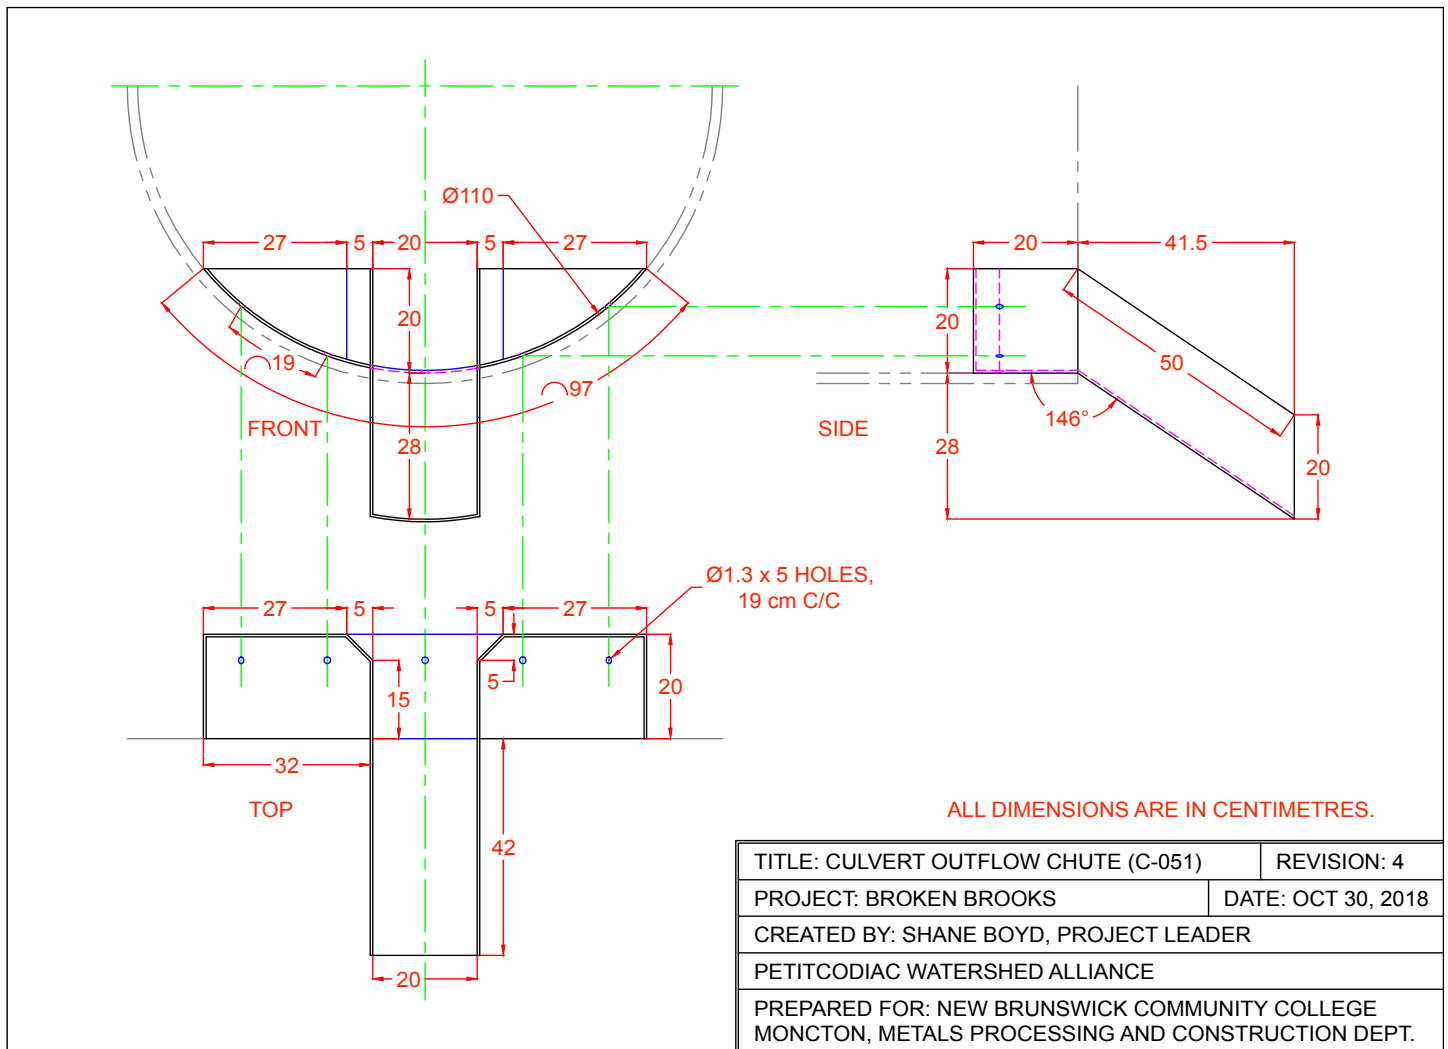
Figure 5: Front, top, and side views with dimensions of outflow chute for culvert C-051

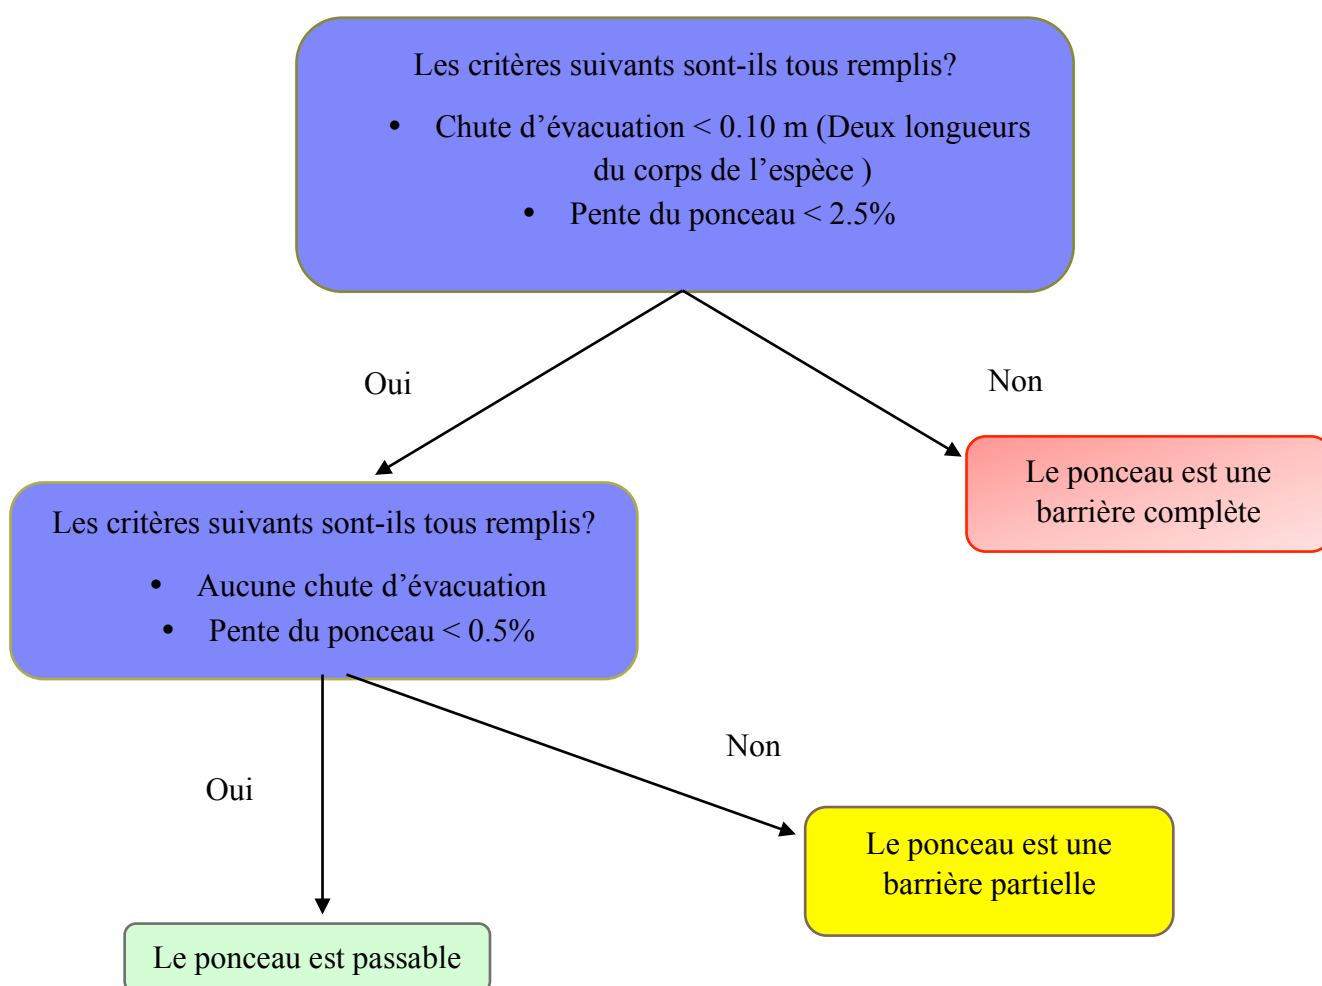
Appendix C: French Translation of ACCAT Barrier Classification System and Flow Chart

Type de barrière	Critères
Passable	Les critères suivants doivent être remplis: Aucune chute d'évacuation Pente du ponceau < 0.5%
Barrière partielle	Au moins un des critères suivants est rempli: Chute d'évacuation < 10 cm Pente du ponceau entre 0.5% - 2.5%
Barrière complète	Au moins un des critères suivants est rempli: Chute d'évacuation > 10 cm Pente du ponceau > 2.5%

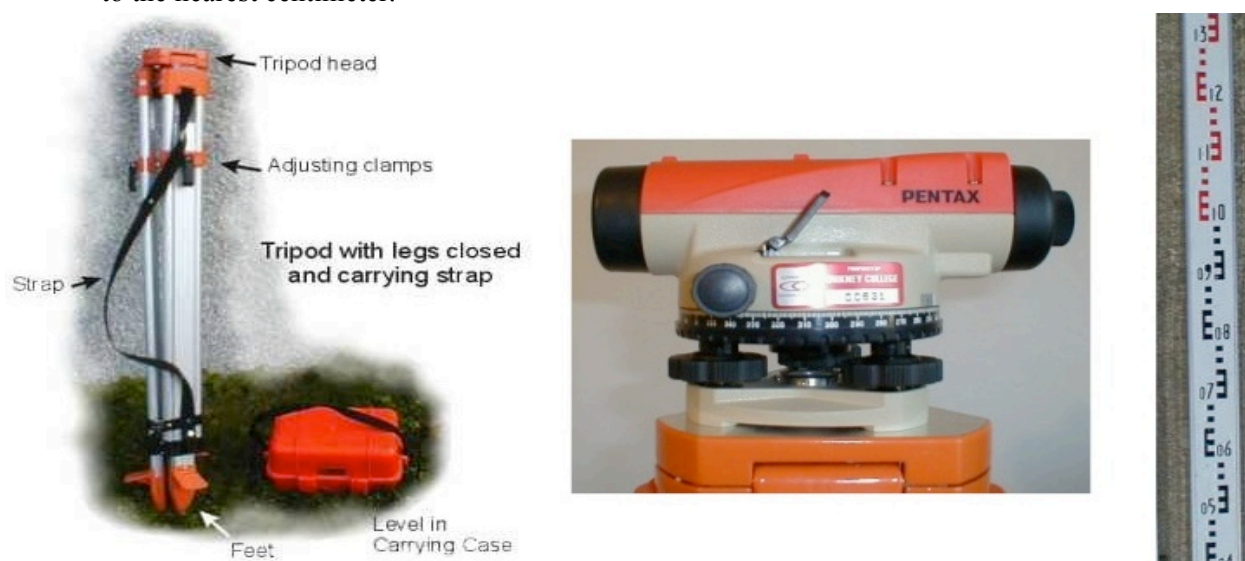
1. **Tripod:** as indicated in its name, the tripod has 3 ‘legs’ that are adjustable for height. The automatic level will be secured onto the top of the tripod for the duration of the surveying procedure.
2. **Automatic Level:** Elevation measurements are taken by reading the staff through the lens of the automatic level.
3. **Staff:** 5 meter long measuring stick, divided into meters and centimeters. Readings are measured to the nearest centimeter.

Figure 8: Pictures of the 3 pieces of equipment required for surveying: the tripod (left), the automatic level (center) and the staff (right) (Photographs of surveying equipment, n.d.).

The automatic level survey is an optical instrument that provides a height of reference from which you can determine changes in elevations, and in doing so the slope, from one location to another. The equipment required to conduct surveying are outlined below (must have a minimum of 2 people):

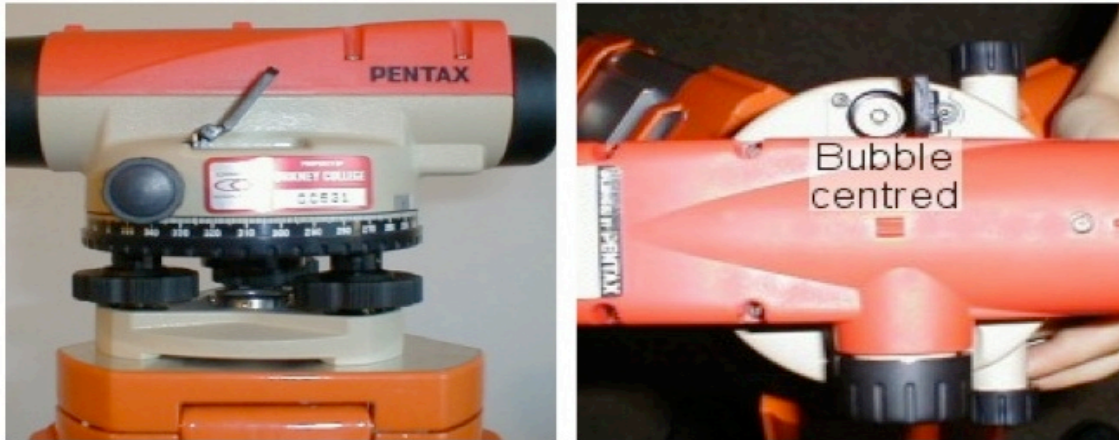
Once the tripod is set up at a comfortable height and relatively level, place and secure the automatic level onto the tripod head. Use the three leveling screws to bring the bubble within the circle on the spherical level. Once the bubble is centered staff readings can be taken.

Figure 9: The automatic level must be secured onto the tripod head (left) before using the 3 leveling screws to bring the bubble within the circle on the spherical level (right). Once the bubble is centered, staff readings can be taken (Photographs of surveying equipment, n.d.).

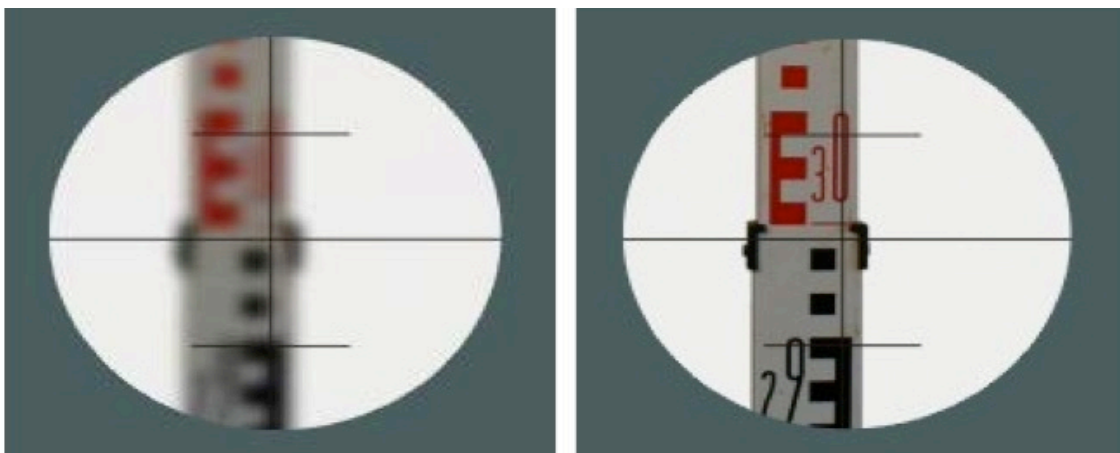
After the tripod is set-up, look through the lens and rotate the level until the staff is visible. Focus the eyepiece and read the numbers (to the nearest centimeter) on the staff where the horizontal and vertical crosshairs meet.

Figure 10: Pictures of the staff while looking through the automatic level before (left) and after (right) the lens is focused. The staff reading in this example is 2.99 m (Photographs of surveying equipment, n.d.).
